ESL-TR-91-13
VOL II

**EXPEDIENT REPAIR OF STRUCTURAL
FACILITIES (ERSF) - VOLUME II: ERSF
SYSTEM REQUIREMENTS AND USERS
GUIDE**

**APPLIED RESEARCH ASSOCIATES, INC.
P. O. BOX 40128
TYNDALL AFB FL 32403**

JULY 1991

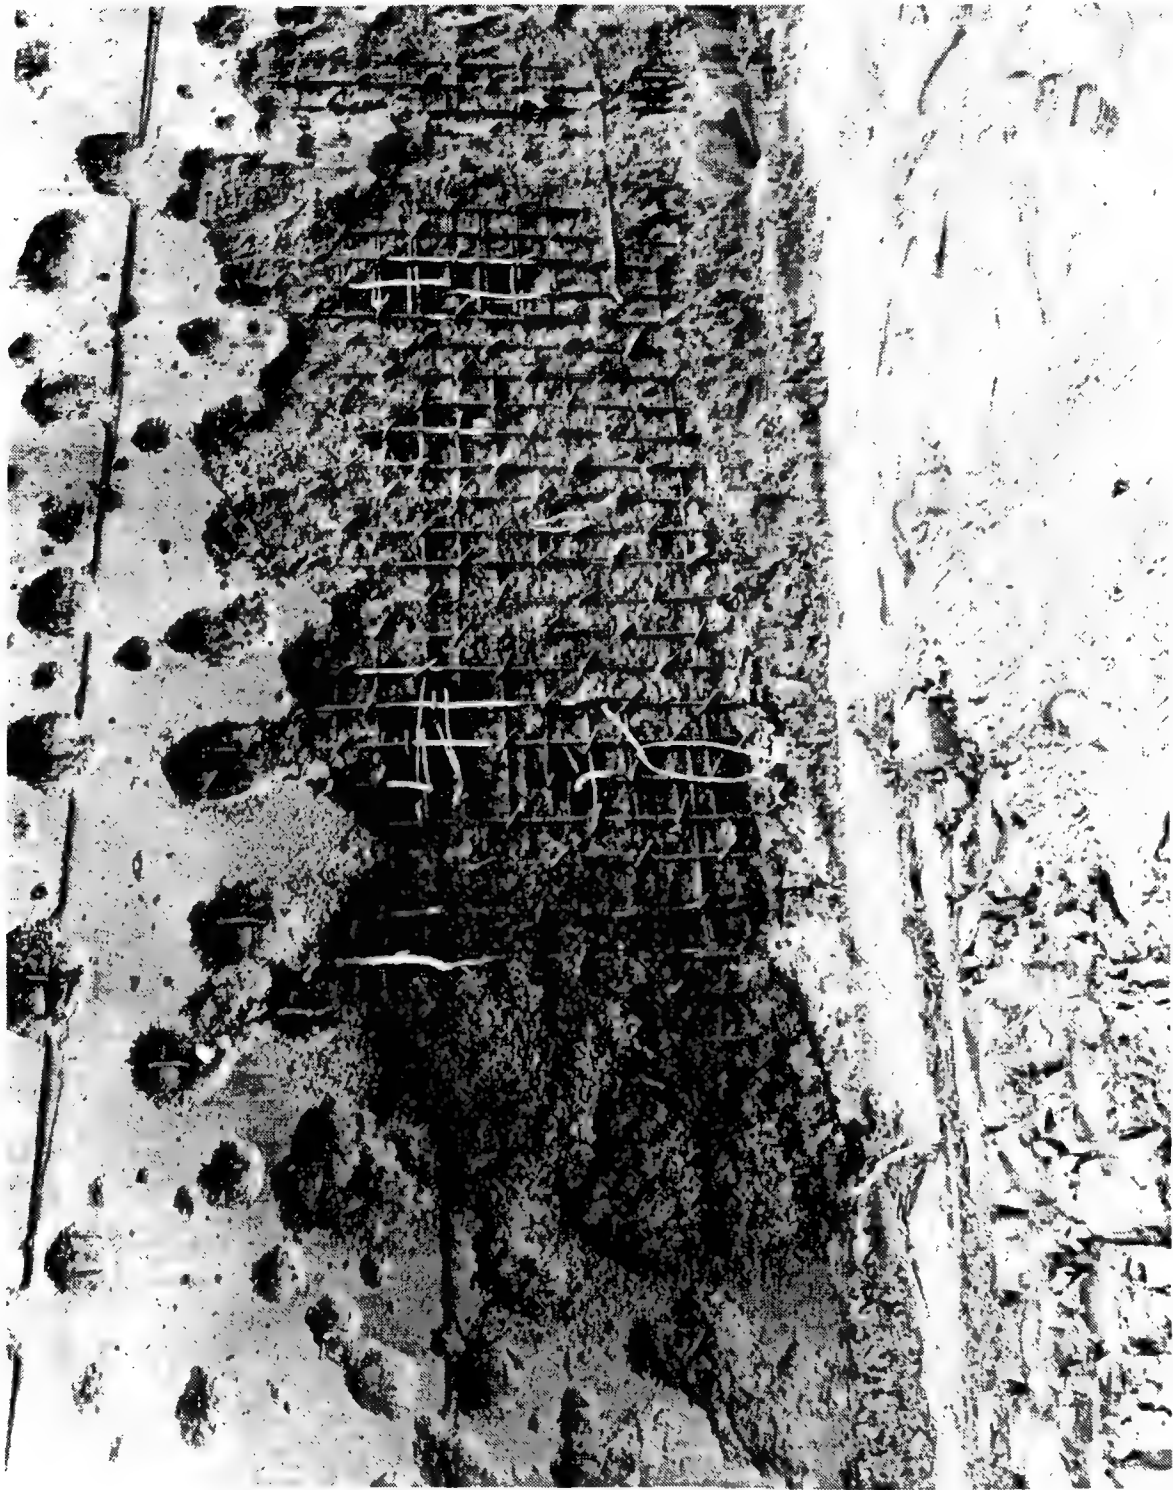
Figure 70. Completed Simulated Shotcrete Wall Breach Repair.

The repair area after shotcreting is shown in Figure 70, while the clogged feed cylinders of the shotcrete gun are shown in Figure 71. Upon investigation, it was determined that clogging of the cylinders was caused by having too large a surcharge of material in the gun hopper and wood feed funnel above the hopper. To alleviate this problem, the wood funnel was discarded, and only 3 or 4 inches of material was maintained in the hopper. Consequently, continuous monitoring of the shotcrete hopper was required, with frequent small feedings of material from the concrete bucket into the hopper. These new procedures were used during the wall replacement demonstration described below.

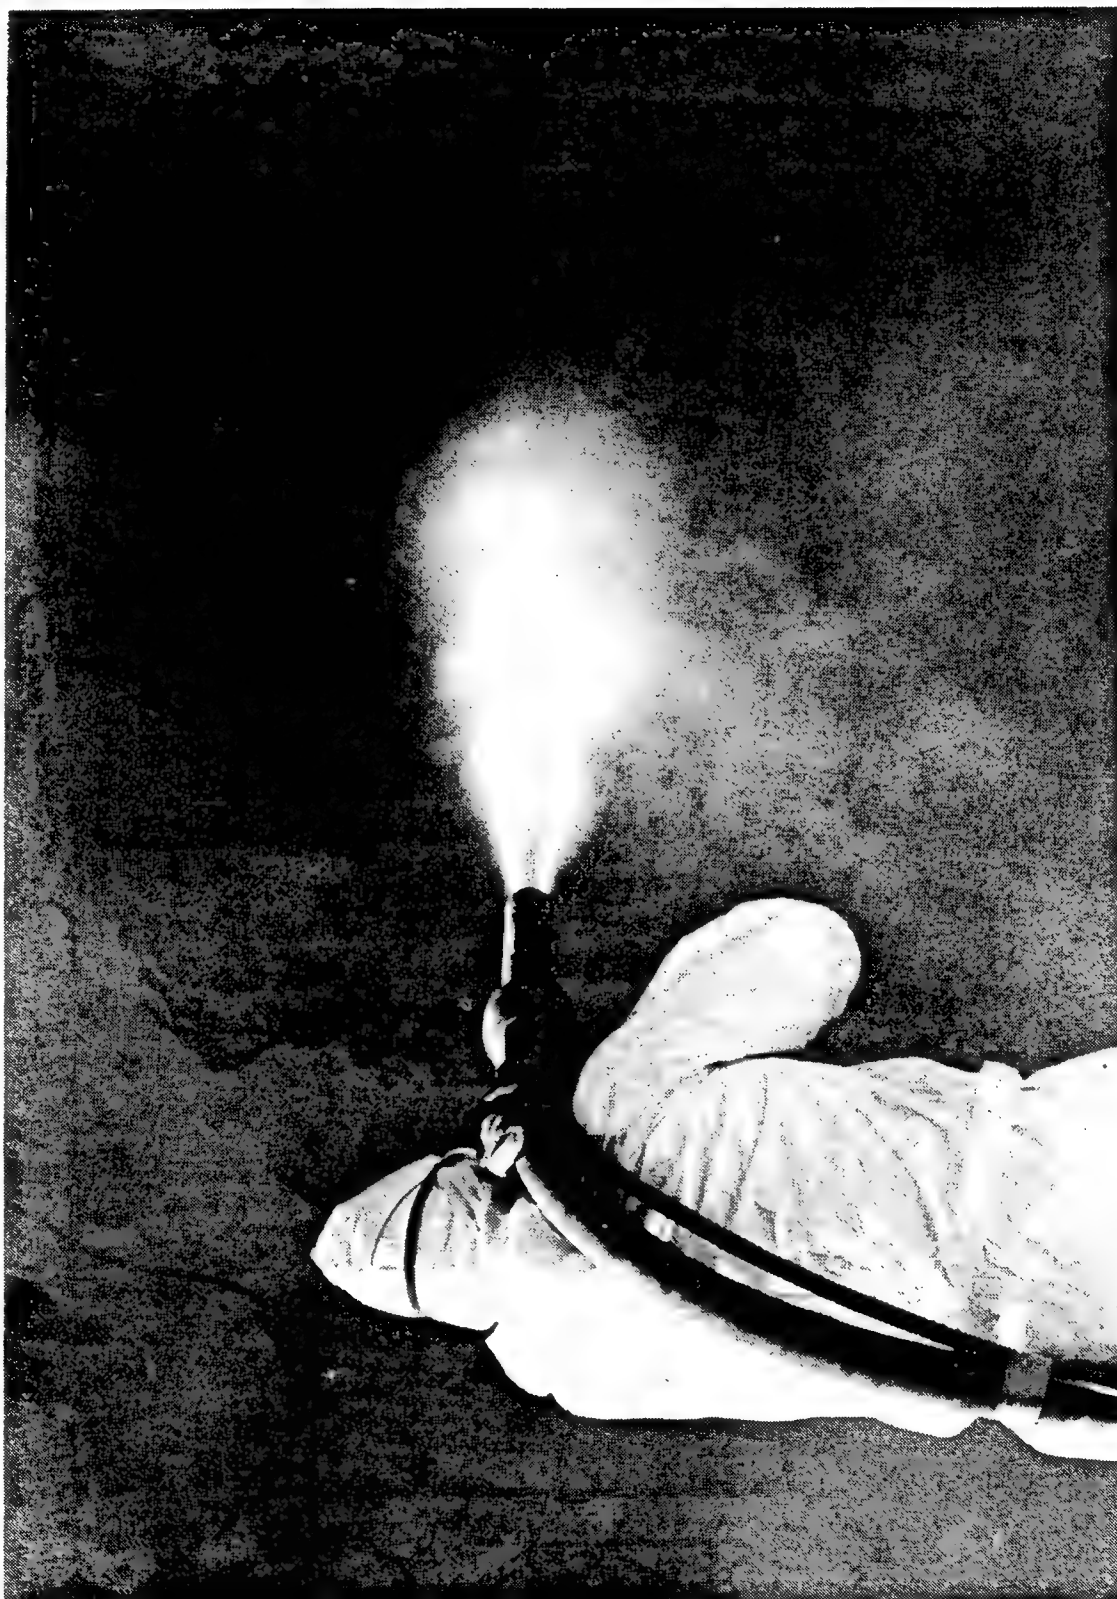
Figure 72. Pre-Dampening Attachment for the Shotcrete Nozzle.

On this day (22 October), a change in the shotcrete equipment setup was tried. A pre-dampening hose was attached to the shotcrete nozzle. This attachment allowed the nozzle operator to control the water content of the shotcrete material. The pre-dampening attachment is shown in Figure 72. With this new arrangement, the exact water content of the material was not known, but the nozzle operator could visually determine the quality of

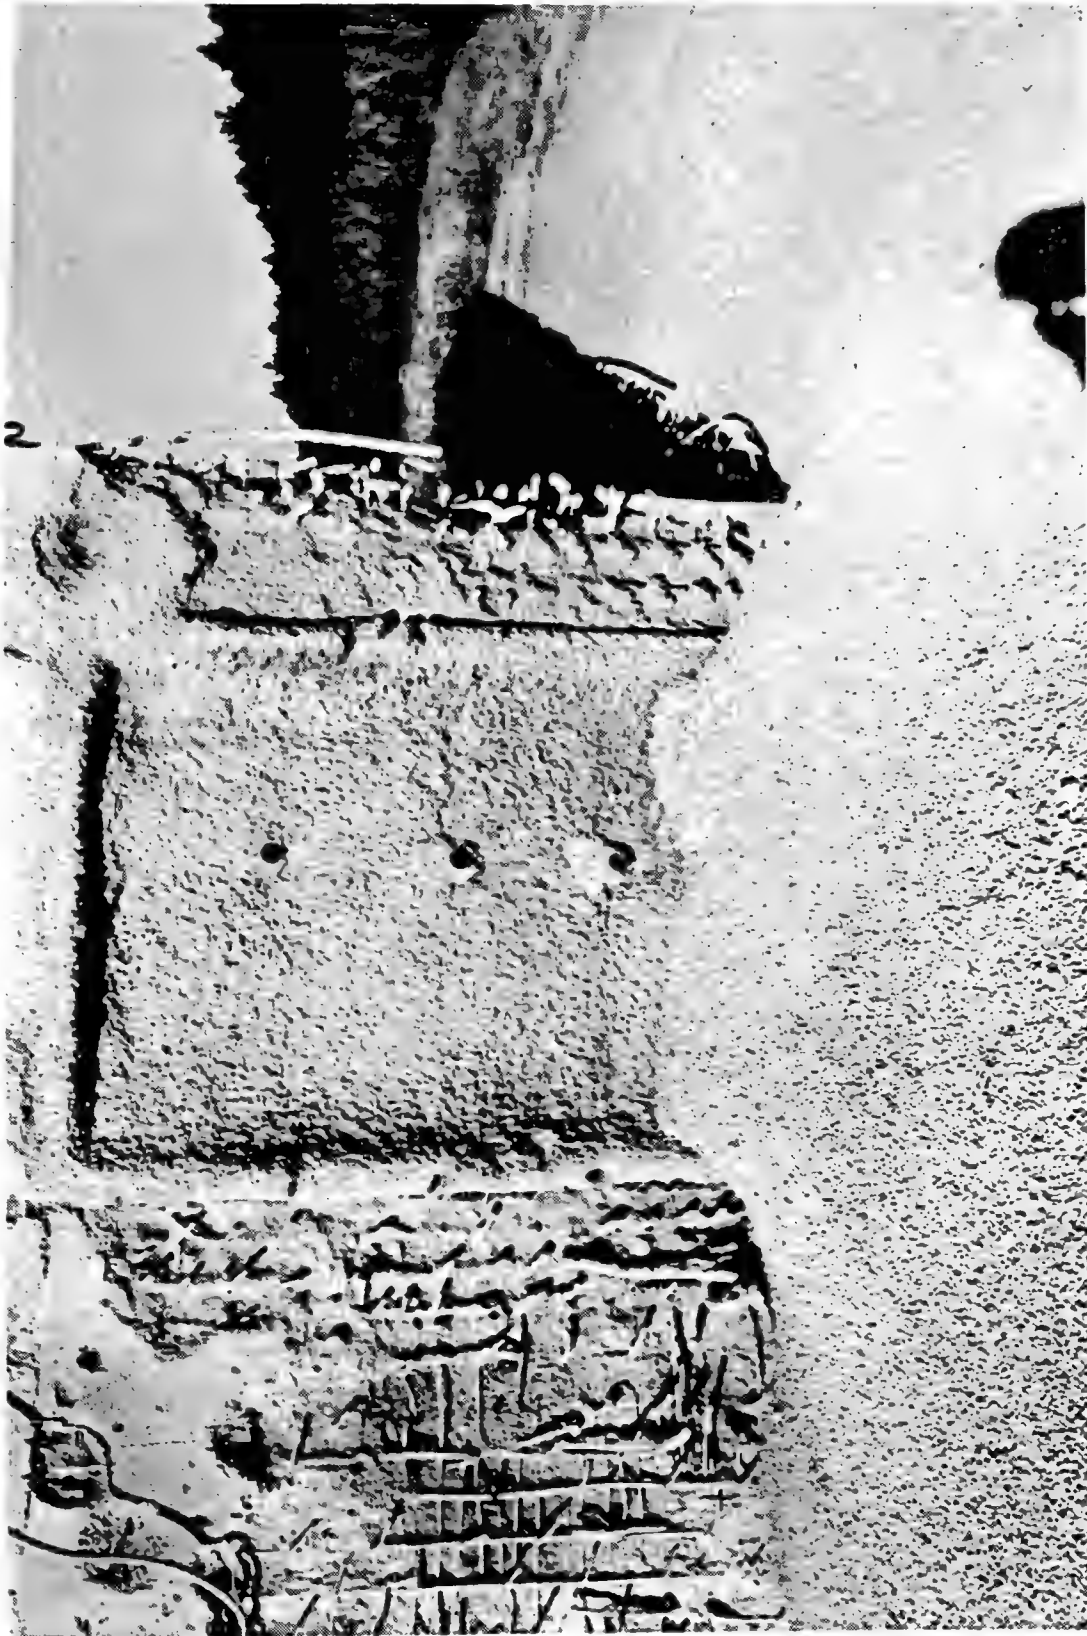
Figure 73. Completed Shotcrete Wall Replacement Repair.

Total shotcrete repair time on Day 2, excluding delays, was 34 minutes. The total time required to fill the concrete bucket twice, and position it over the shotcrete gun hopper was 65 minutes. Total demonstration time on Day 2 was 99 minutes. The completed wall replacement repair is shown in Figure 73. Due to shotcrete rebound, a large ramp of material was formed at the bottom of the repair, as shown in Figure 74.

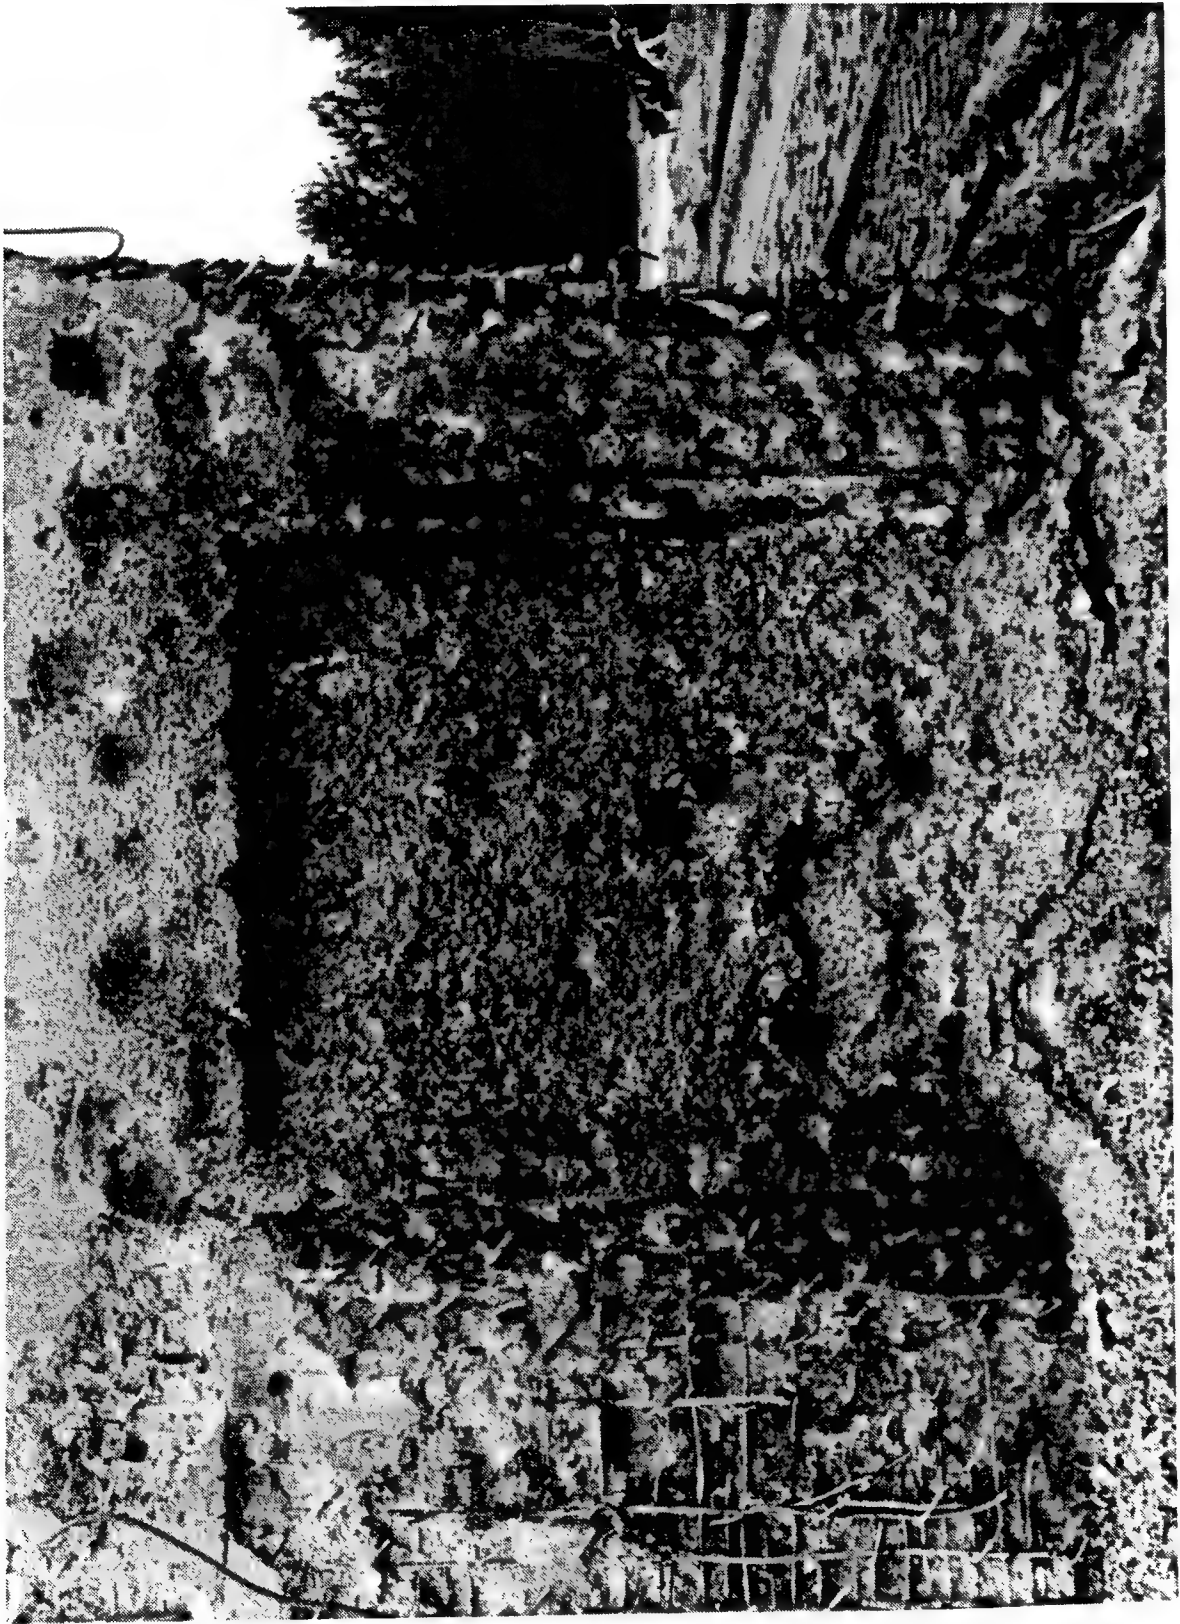
Figure 75. Repair Area After the Explosion of a Mark 83 Bomb at 50 Feet.

On 8 December, a Mark 83 1,000-pound bomb, in a nose-tangent configuration, was exploded 50 feet from the repair. Figure 75 shows the appearance of the repair after the blast. Fragments from the bomb impacted the repair, and penetrated several inches, but none passed completely through. Some minor cracking could be seen at the backside of the repair, as is shown in Figure 76. Due to problems with the instrumentation system, no blast pressure or acceleration data was recorded.
